# Occipital Erosion and Pain from Excess Superior Rods as a Complication of Atlantoaxial Fusion

## Abstract

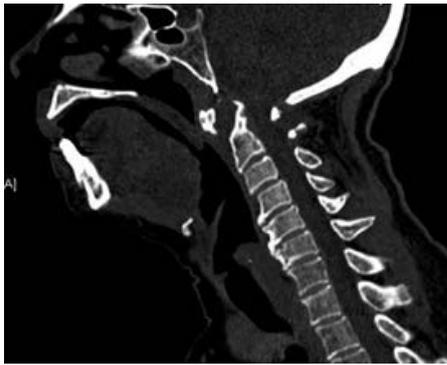
**Figure 1a.** Sagittal CT demonstrating severe erosion of the odontoid and enlarged atlantodental interval.

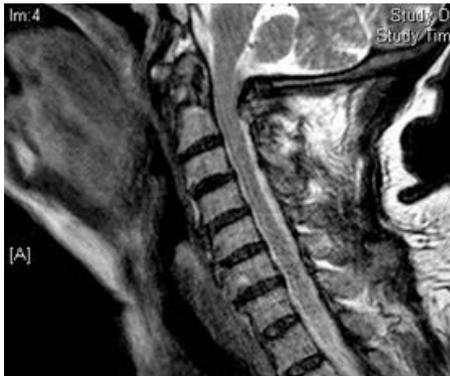
**Figure 1b.** Sagittal T2-weighted MRI demonstrating large pannus formation at the odontoid with compression of the spinal cord at the cervicomedullary junction.

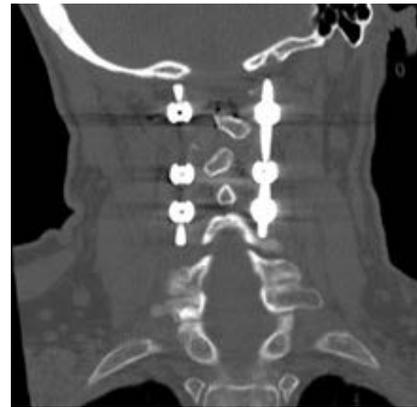
**Figure 1g.** coronal CT demonstrating the fusion construct.

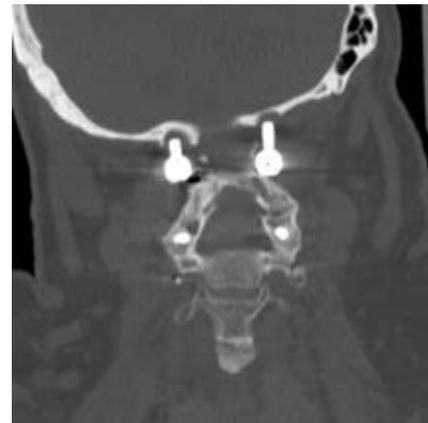
**Figure 1h.** coronal CT demonstrating bilateral rod erosion of the occiput, left greater than right, with erosion to the inner cortical table on the left.

Occipital pain with bony erosion is a potential complication of C1-2 posterior fusion with screw-rod instrumentation if excess rod contacts the occipital bone in extension, and revision surgery to trim excess prominence of the rostral end of a construct may successfully treat the symptoms. Complication avoidance measures may include careful assessment of occipital position in extension on preoperative flexion-extension x-rays and particular attention to placement of fixation rods such that a minimum of rod projects above the C1 tulip heads.

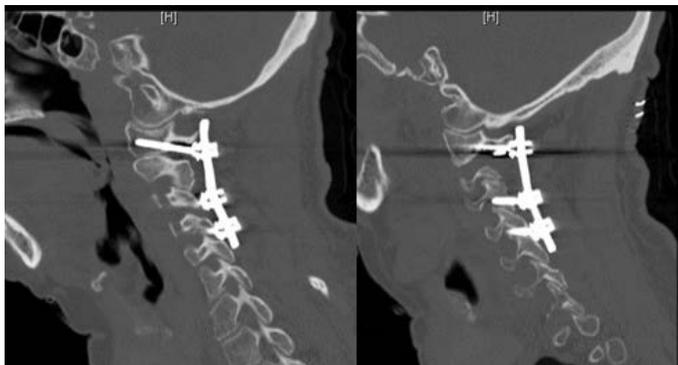
**Figure 1c,1e.** Left and right sagittal immediately postoperative CT images demonstrating the fusion construct from C1-C4

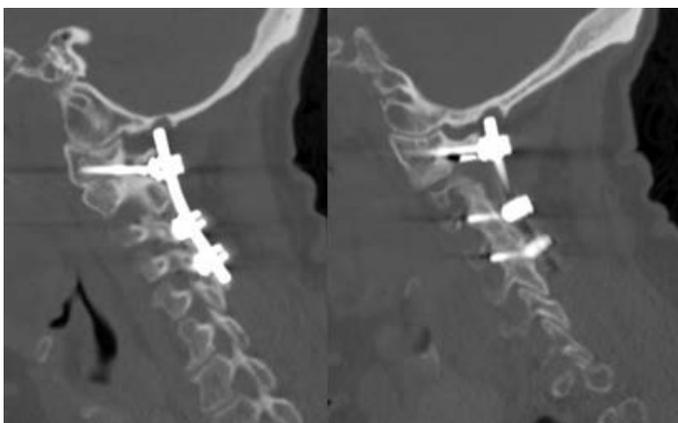
**Figures 1d,1f.** Sagittal 4-year postoperative images demonstrating solid fusion mass yet erosion of the occiput due to rostral rod encroachment.
